Manhole Inspection Summary

Manhole # S31GG1019MH

Insp Date: **12/8/06 11:05 AM**

Location Address: **LINKWOOD RD**

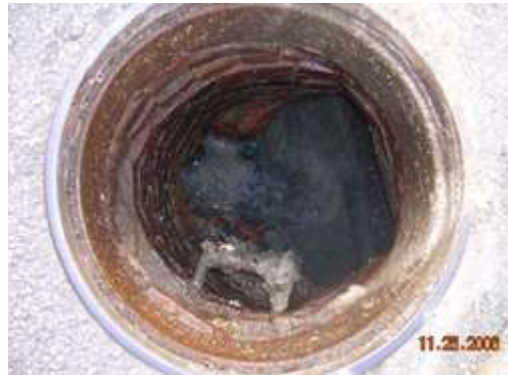
Top View

Corroded steps. Evidence of surcharge - Bench debris.

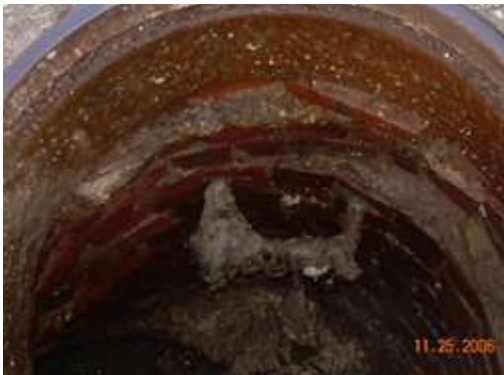
Defect

Frame leaks. Adjustment infiltration.

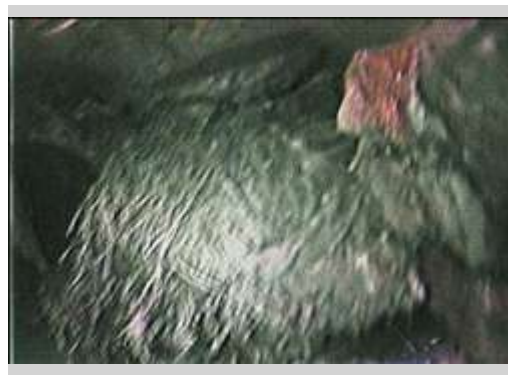
Defect

Channel root intrusion.

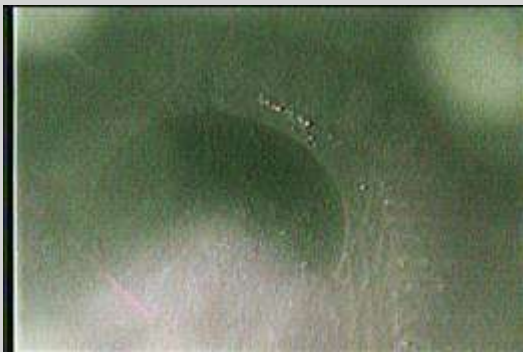
18 in. Circular Gravity Sewer Pipe Out @ 12 O'Clock

Infiltration: **None** Pipe Seal Cond: **Roots**

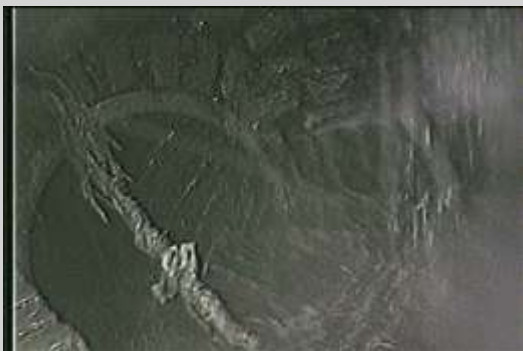
18 in. Circular Gravity Sewer Pipe In @ 6 O'Clock

Infiltration: **None** Pipe Seal Cond: **Roots**

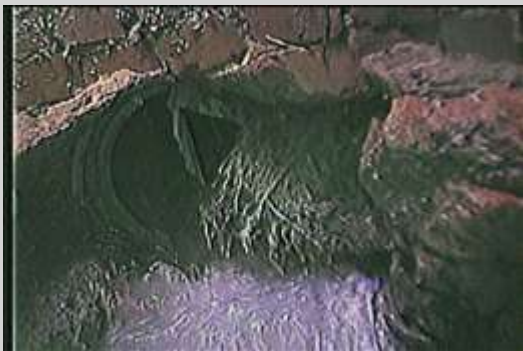
10 in. Circular Gravity Sewer
Pipe In @ 10 O'Clock

Barrel deterioration, root intrusion and infiltration. Channel deterioration and root intrusion.

Infiltration: **None** Pipe Seal Cond: **Roots**
